DEPARTMENT OF TRANSPORTATION**DIVISION OF ENGINEERING SERVICES**

Quality Assurance and Source Inspection

Contract #: 04-0120F4Cty: SF/ALA Rte: 80 PM: 13.2/13.9File #: 69.28**WELDING INSPECTION REPORT****Resident Engineer:** Pursell, Gary**Address:** 333 Burma Road**City:** Oakland, CA 94607**Report No:** WIR-002826**Date Inspected:** 06-Jun-2008**Project Name:** SAS Superstructure**OSM Arrival Time:** 630**Prime Contractor:** American Bridge/Fluor Enterprises, a JV**OSM Departure Time:** 1530**Contractor:** Zhenhua Port Machinery Company, Ltd (ZPMC), Changxing Island **Location:** Shanghai, China**CWI Name:** Hu Wei Qing and Shazhi**CWI Present:** Yes No**Inspected CWI report:** Yes No N/A**Rod Oven in Use:** Yes No N/A**Electrode to specification:** Yes No N/A**Weld Procedures Followed:** Yes No N/A**Qualified Welders:** Yes No N/A**Verified Joint Fit-up:** Yes No N/A**Approved Drawings:** Yes No N/A**Approved WPS:** Yes No N/A**Delayed / Cancelled:** Yes No N/A**Bridge No:** 34-0006**Component:** OBG and SAS Tower Fabrication**Summary of Items Observed:**

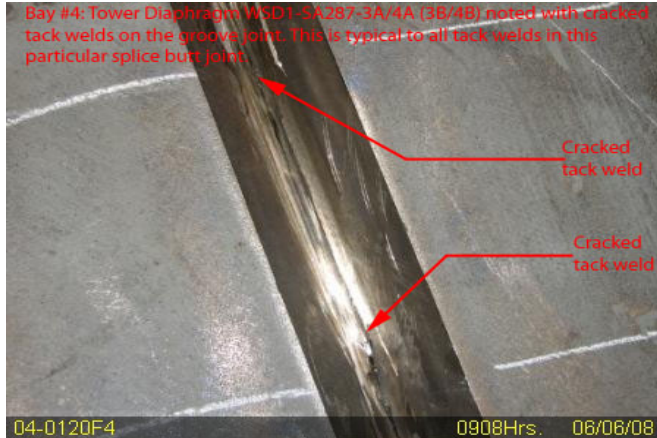
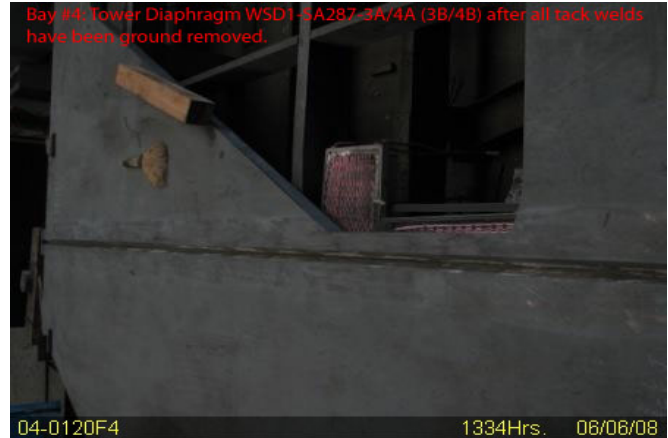
This QA was called by ZPMC QC to verify the existence of cracked tack welds they have found on tower diaphragm plate splice butt joint on WSD1-SA267-3A/4A (3B/4B). This QA observed that several of the butt groove tack welds have indeed cracked on both ends of each tack weld (around 80% of the tacks were affected). One ABF Inspector Xiao Jun Peng and ABF QA Manager Don Walton were present at the scene assessing the situation and informed this QA that they already notified Caltrans regarding this incident. Per Mr. Walton and during their conversation (between Caltrans and ABF) it was agreed to remove all the tack welds in this particular splice butt joint. This QA observed ZPMC personnel grinding off the tack welds and sometime during the end this shift all the tack welds were seen completely ground. See two photos below.
